Vacuum cleaner

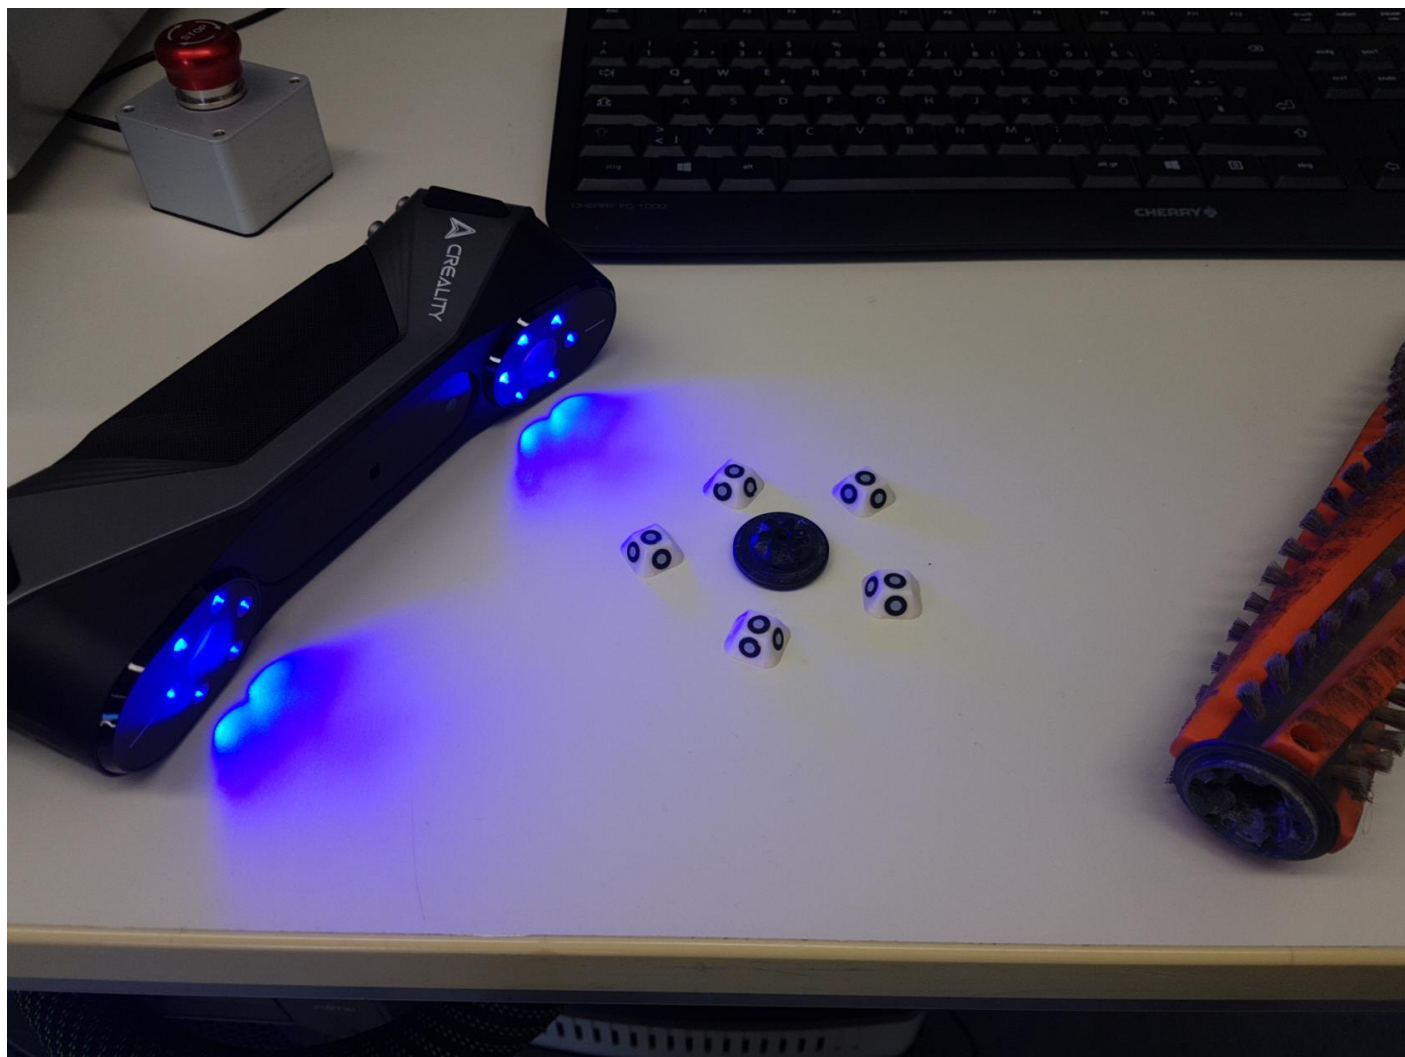
I 3D-scanned the clutch with our CR-Scan Raptor in blue laser mode. For this to work, you need several tracking points around the object.

Here you can see the result of the scan.
