Vacuum cleaner

My neighbours gave me this vacuum-cleaner brush that didn't work anymore because it stopped spinning. The connecting piece was so worn out, that the "clutch" piece would spin freely inside it.

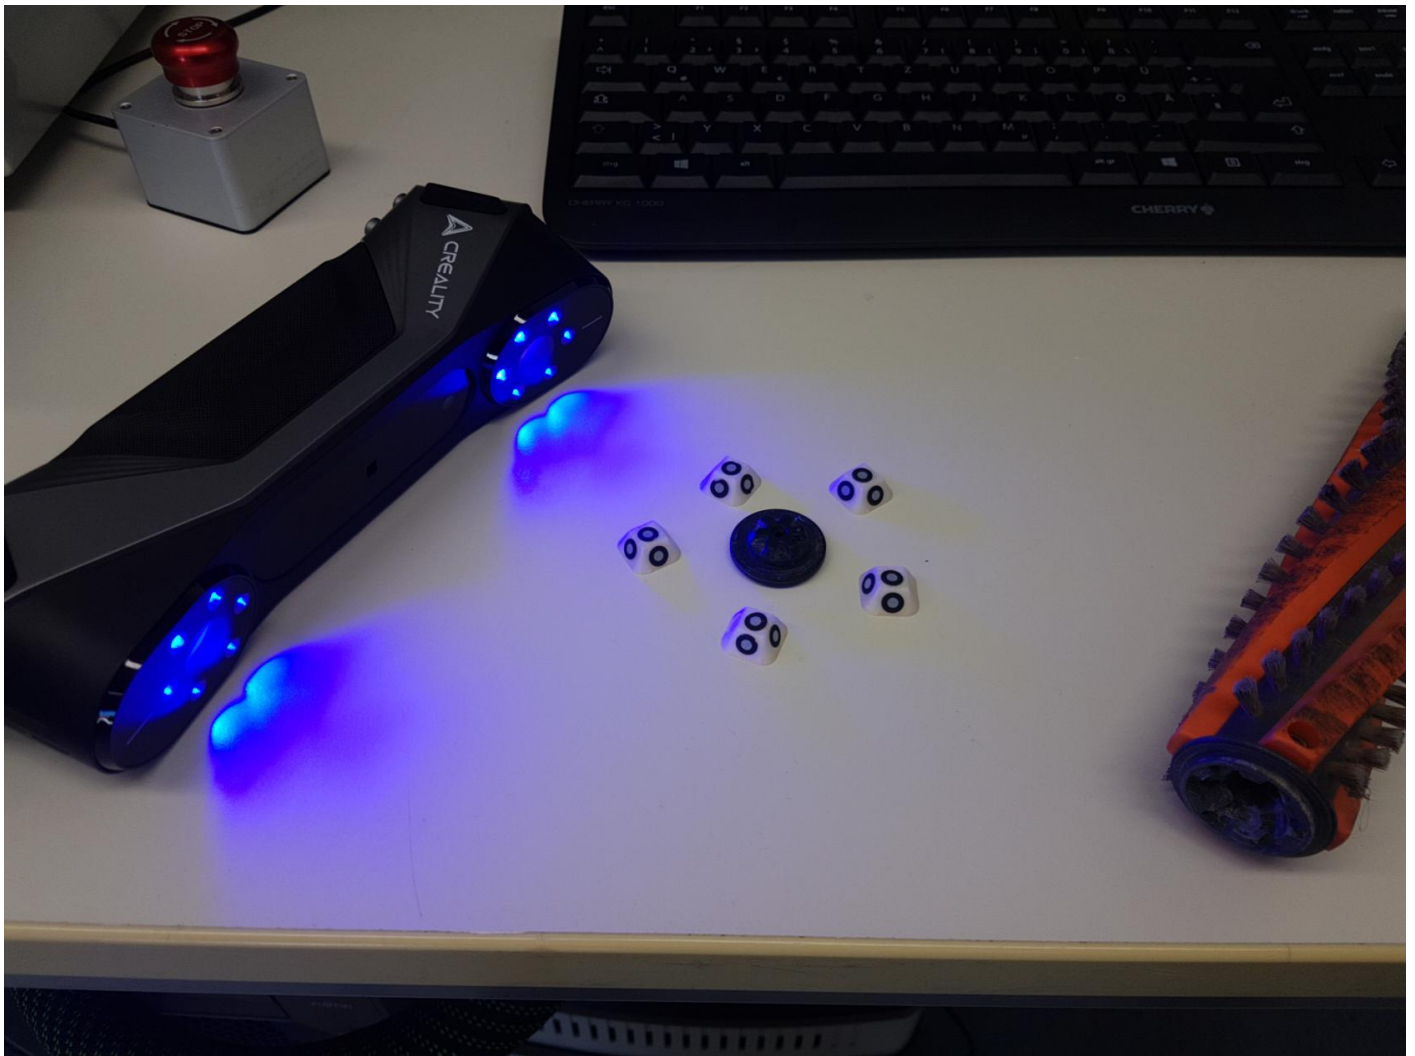
I 3D-scanned the clutch with our CR-Scan Raptor in blue laser mode. For this to work, you need several tracking points around the object.

Here you can see the result of the scan.

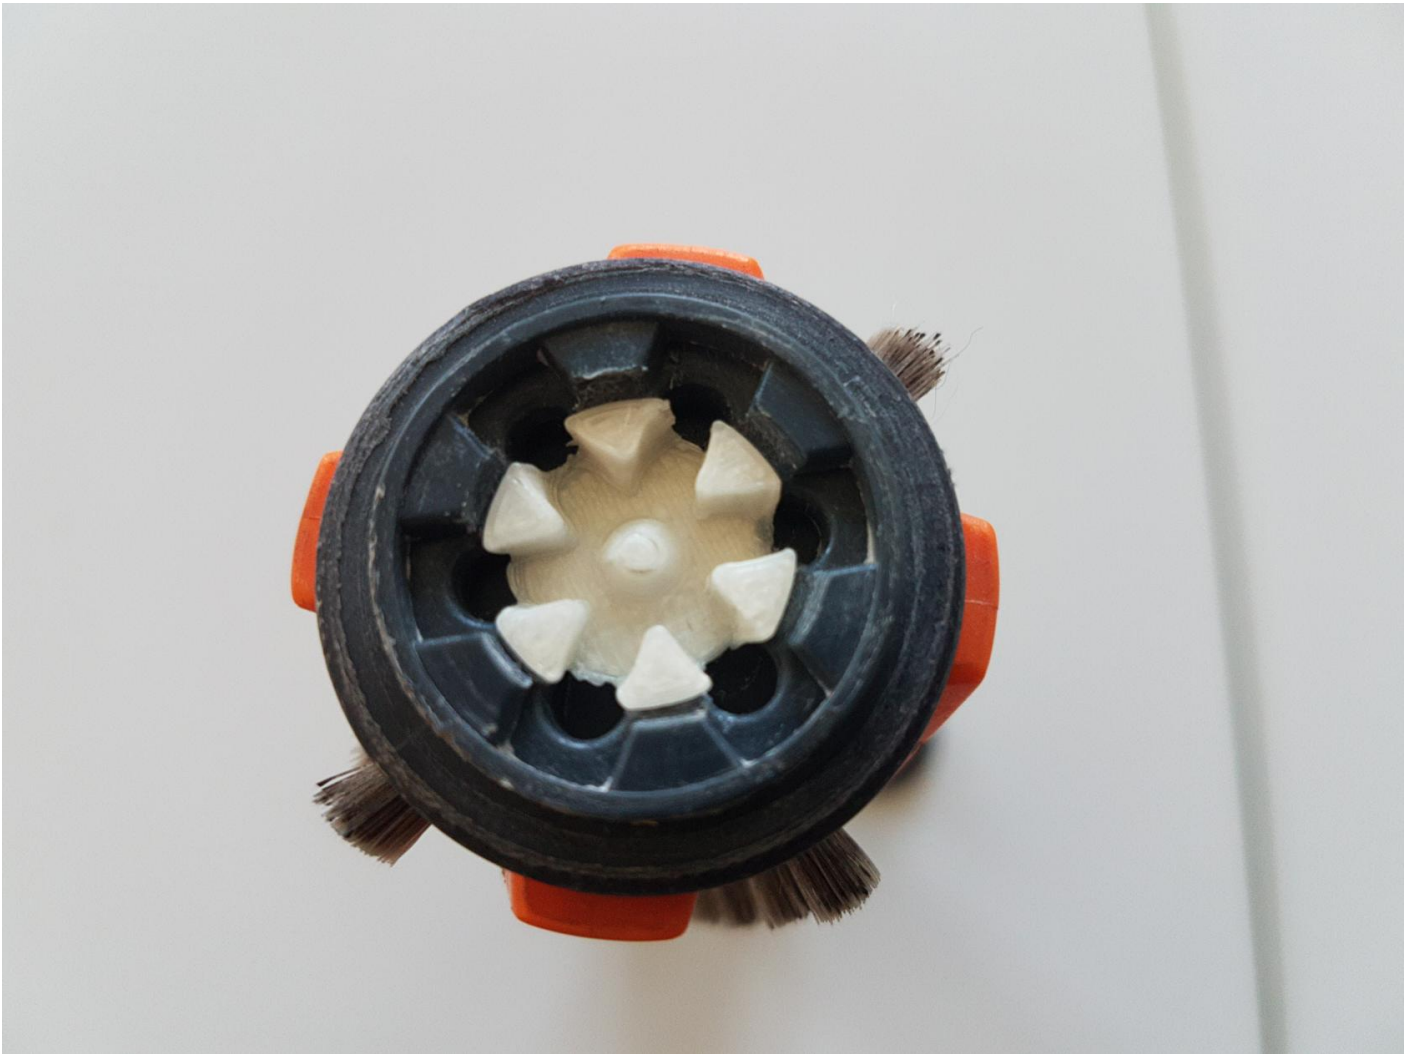
This is what the finished result looks like:
