Vacuum cleaner

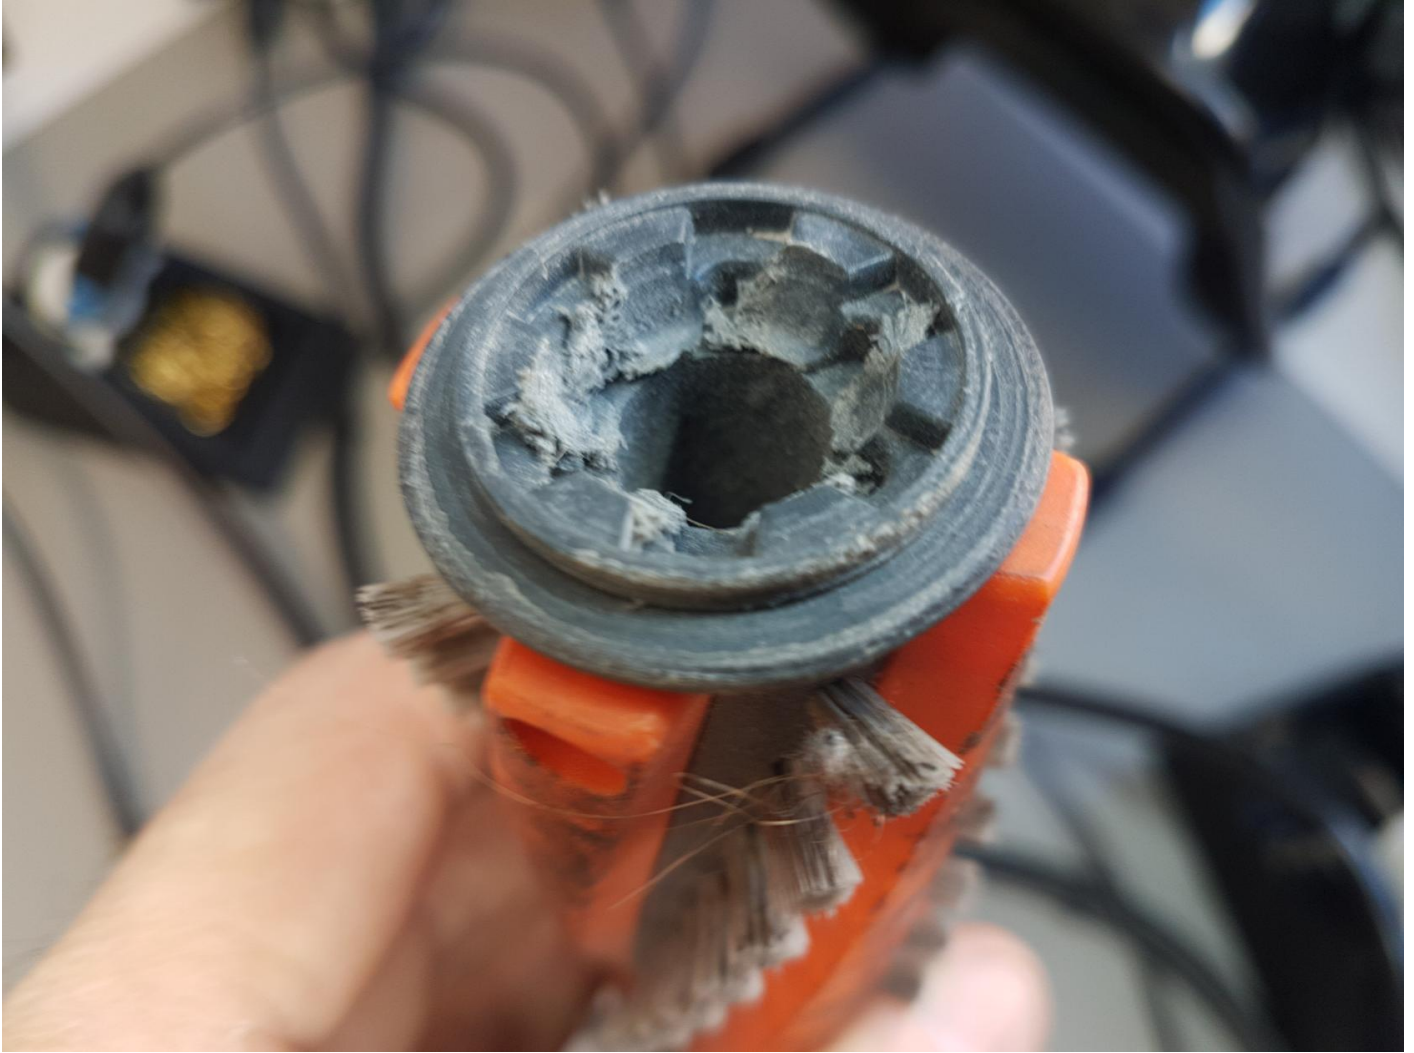
My neighbours gave me this vacuum-cleaner brush that didn't work anymore because it stopped spinning. The connecting piece was so worn out, that the "clutch" piece would spin freely inside it.

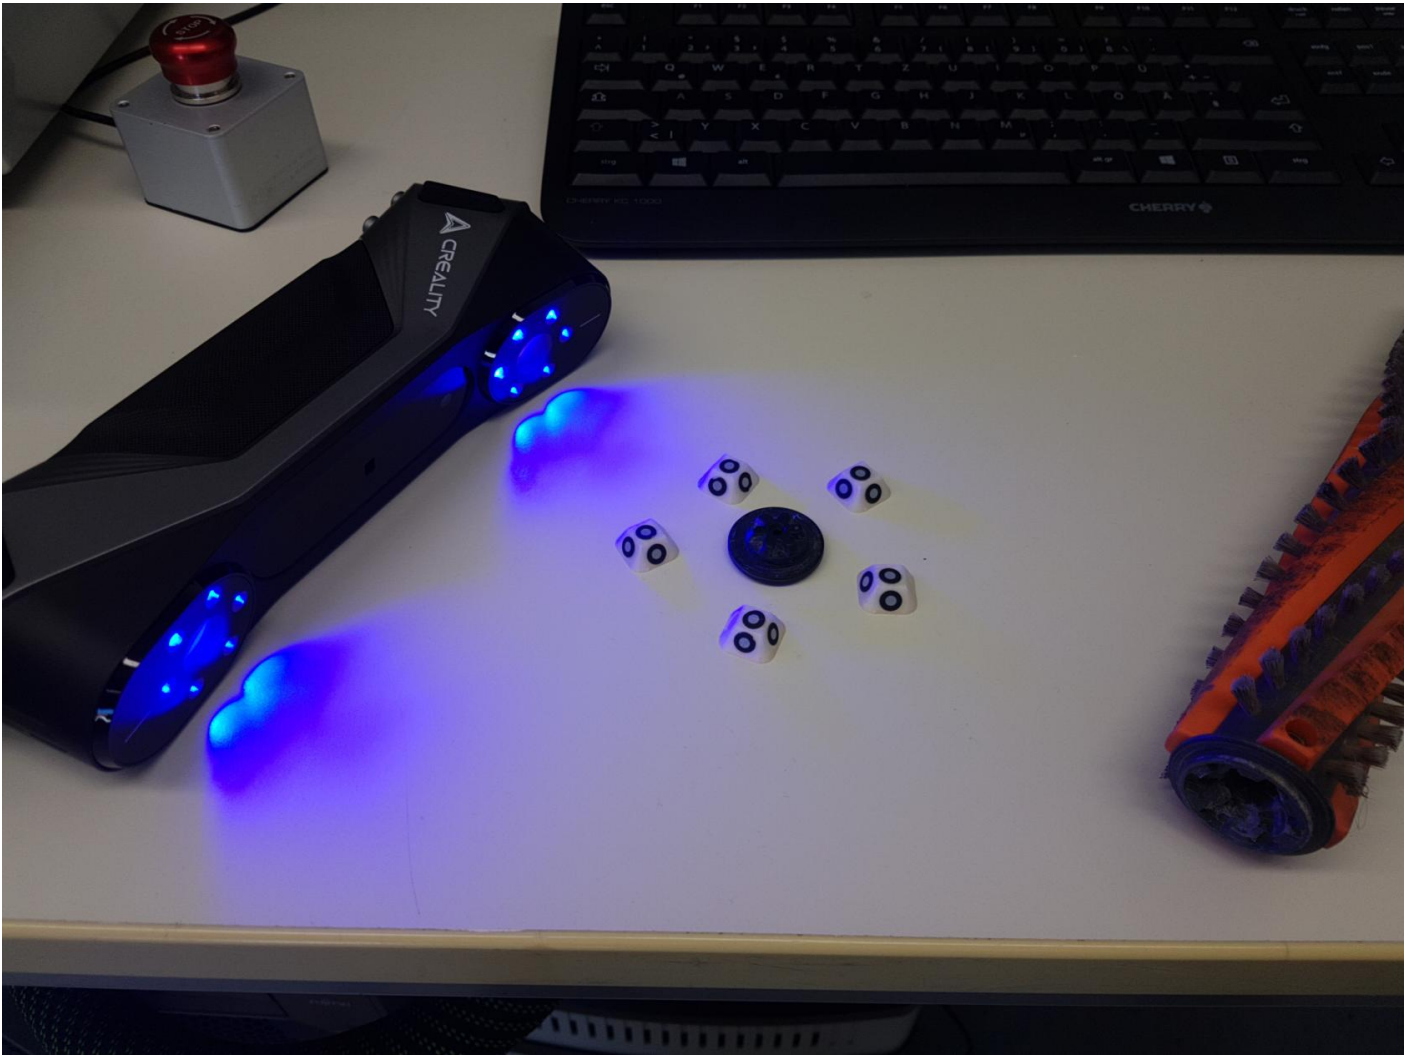
I 3D-scanned the clutch with our CR-Scan Raptor in blue laser mode. For this to work, you need several tracking points around the object.

Here you can see the result of the scan.

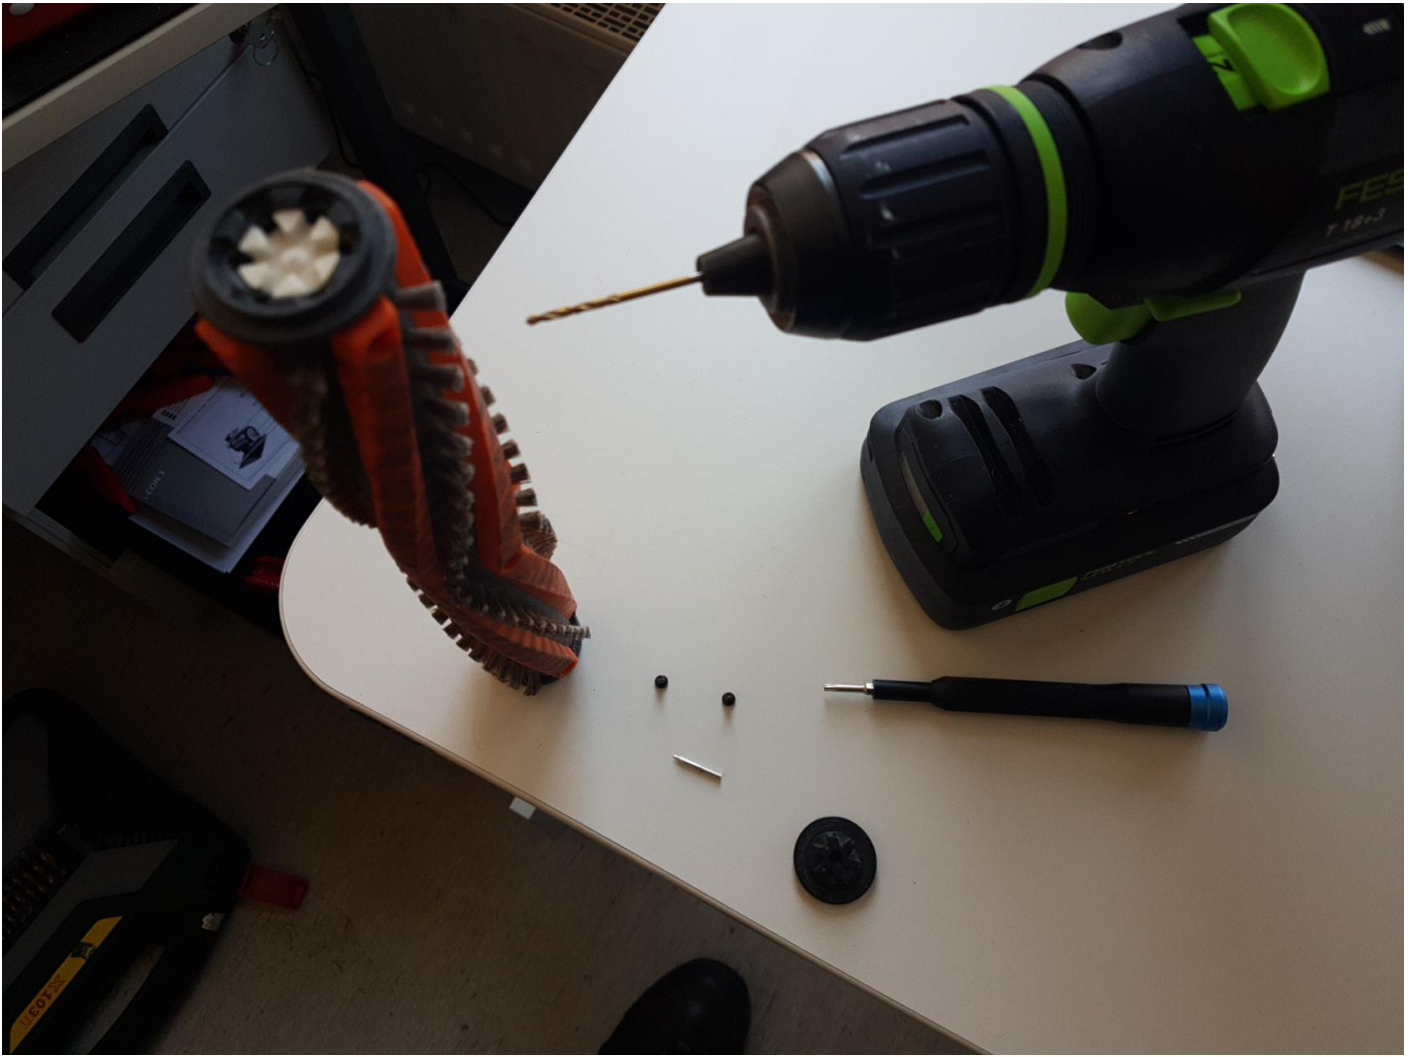
In order to make it removable, I drilled a hole through my printed piece and the brush, in place of one of the screw holes. Now I can securely fix the part in rotation, but still disassemble and replace it if necessary.

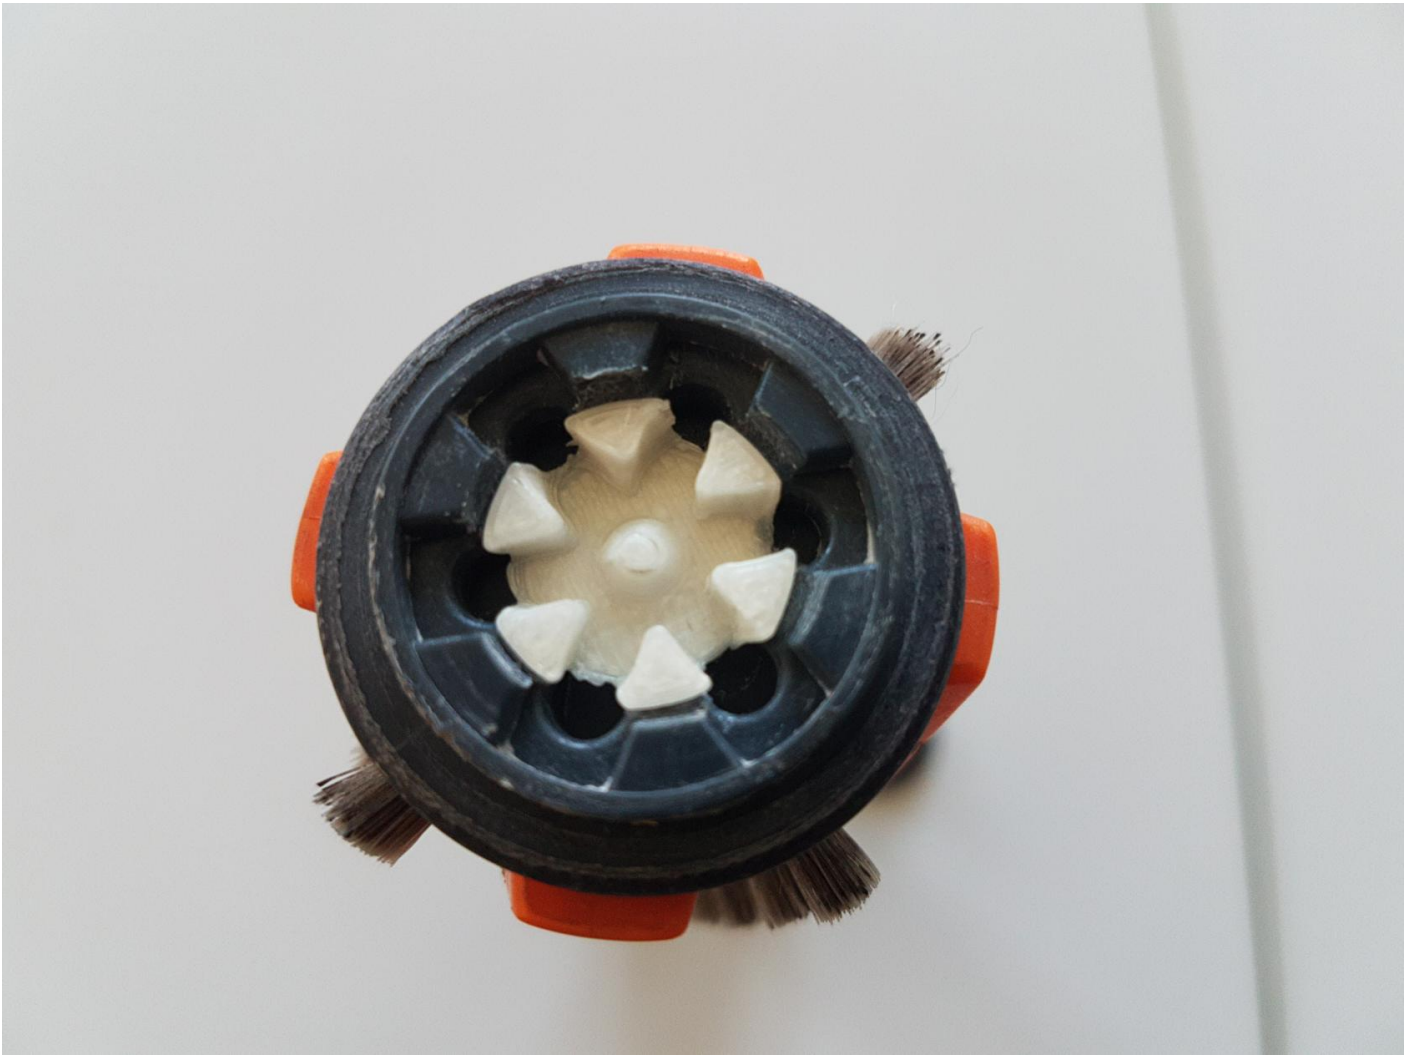
This is what the finished result looks like:
